**Flood Control Project Maintenance
Levee Inspections**

Maintenance Issue Types Only, Levee Inspection Report By Mile - Fall 2018

California Department of Fish and Game Shea Levee

Waterway	Bank	Unit Miles	Inspection Start/End	Inspector
Unit No. 01 Sacramento River	Left	0.30	09/21/2018 09/21/2018	Bob Duffey

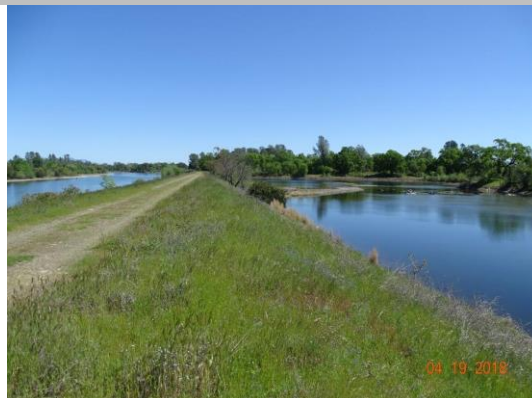
Photo 2 of 2 : FA_2018_NA0018_269_2_20180905_00003.jpg

LM Start	0.00	Rating **	M	Issue No.	2
LM End	0.30	Issue Type +	Ma	Location *	LS
Category	Earthen Levee			GPS Latitude/Longitude	
				Start	End
Item	Vegetation			40.507697°	40.511210°
				-122.363683°	-122.360390°
DWR ID	DWR_NA0018_01_s_2012_2				
Comment Code					
V2 : Remove the wild growth other than native grasses from the levee slopes.					
Inspector Comment					
California Department of Fish and Wildlife has not completed any maintenance several year.

View of the vegetation along the landside slope.

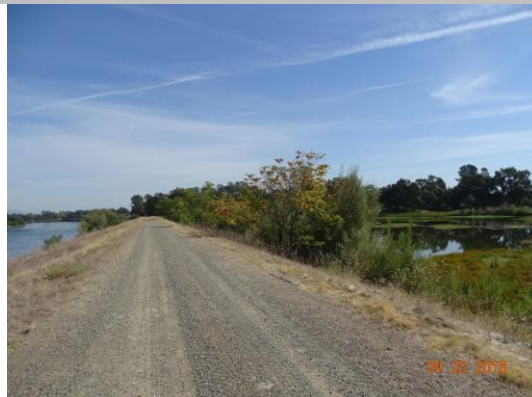
Photo 1 of 1 : FA_2018_NA0018_269_3_20181008_00008.jpg

View of the trees along the landside slope.

LM Start	0.00	Rating **	M	Issue No.	3
LM End	0.30	Issue Type +	Ma	Location *	LS
Category	Earthen Levee			GPS Latitude/Longitude	
				Start	End
Item	Trim / Thin Trees			40.507738°	40.511210°
				-122.363682°	-122.360390°
DWR ID	DWR_NA0018_01_f_2017_3				
Comment Code					
T3 : Trim and thin trees to allow visibility of the ground and room to flood fight.					
Inspector Comment					
Trim and remove trees to allow visibility.

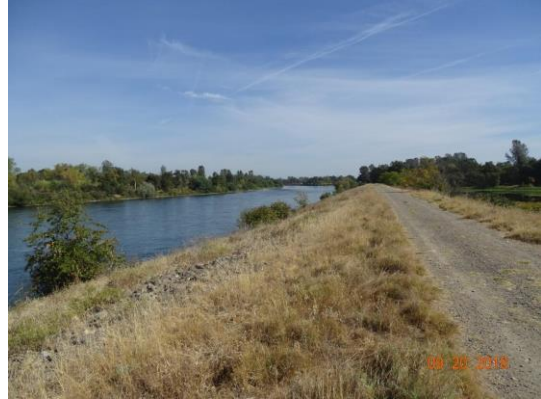
Photo 1 of 2 : FA_2018_NA0018_269_1_20181008_00007.jpg

View of the vegetation along the waterside slope.

LM Start	0.00	Rating **	M	Issue No.	1
LM End	0.30	Issue Type +	Ma	Location *	WS
Category	Earthen Levee			GPS Latitude/Longitude	
				Start	End
Item	Vegetation			40.507697 °	40.510670 °
				-122.363683 °	-122.361203 °
DWR ID	DWR_NA0018_01_s_2012_1				
Comment Code					
V2 : Remove the wild growth other than native grasses from the levee slopes.					
Inspector Comment					
Remove the vegetation from the waterside slope.

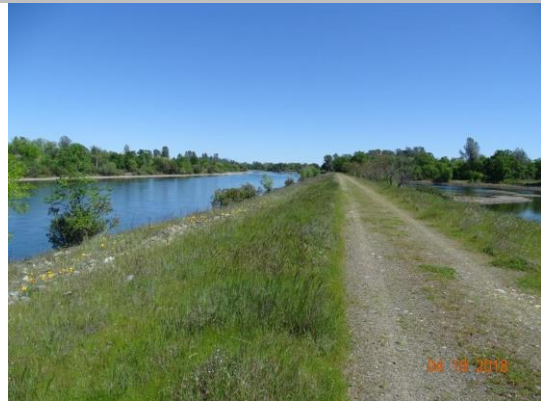
Photo 2 of 2 : FA_2018_NA0018_269_1_20180905_00001.jpg

View of the vegetation along the waterside slope.
